KOTO ADC Boards – 1.2V Power Caps

Mircea Bogdan 12/10/2015

The University of Chicago

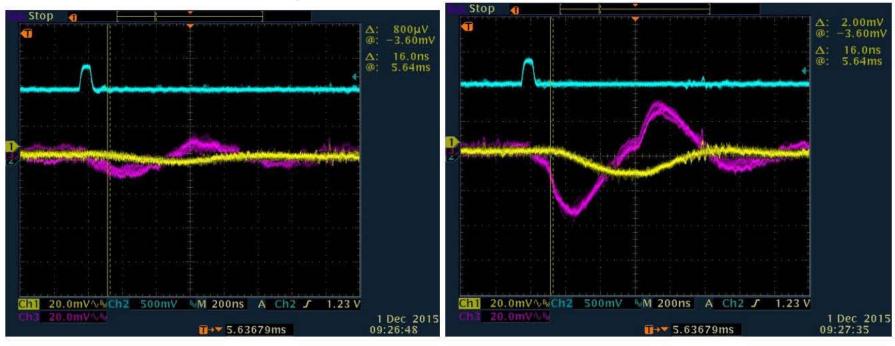
Voltage Test with Compression OFF/ON 2071.sof

The errors were traced back to the ADC Modules, i.e. to temporary (~ 500ns) Voltage drops in the VCCINT=1.2V. These Voltage drops were caused by a temporary increase of current demand from ~1.4A to ~2.3A, due to intense activity inside the FPGA during compression.

H2 Compression OFF OK

Compression ON Bad

The voltage drops with compression OFF are causing no noticeable problems in FPGA functionality.

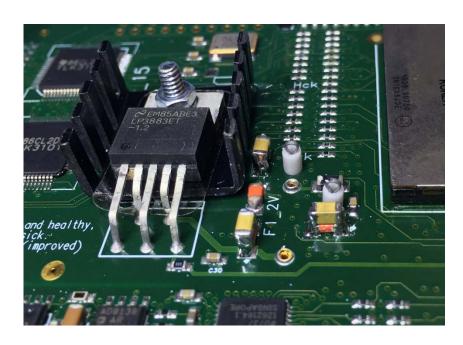
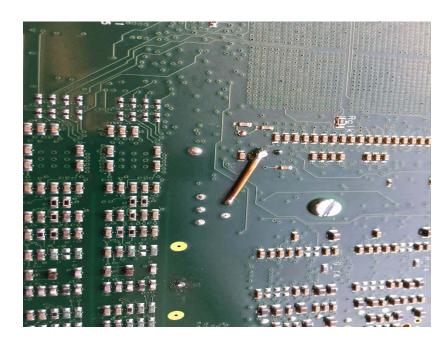
Hardware Solution

The added caps are the 3 yellow ones in the picture. Their sizes are 1206; part # GRM31CR60G227ME11L

On Top Side: Install three 220uF ceramic caps over C26, C27, C29.

On Back Side: Install wire jumper as shown.

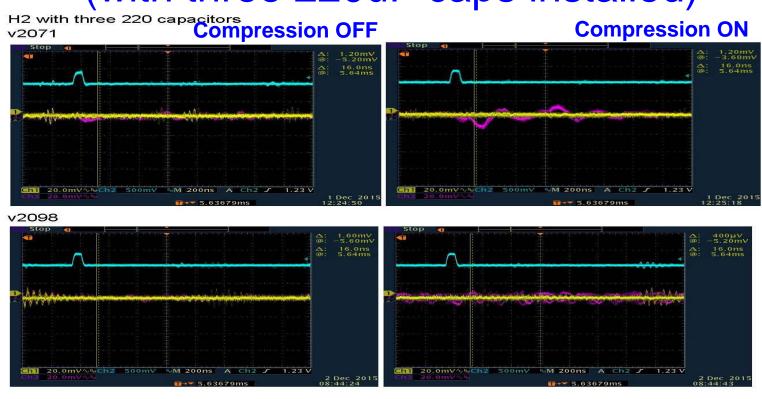
Voltage Test with Compression OFF/ON (with three 220uF caps installed)

After installing the 3 caps, the voltage drop with compression ON is smaller that when compression was OFF with no caps.

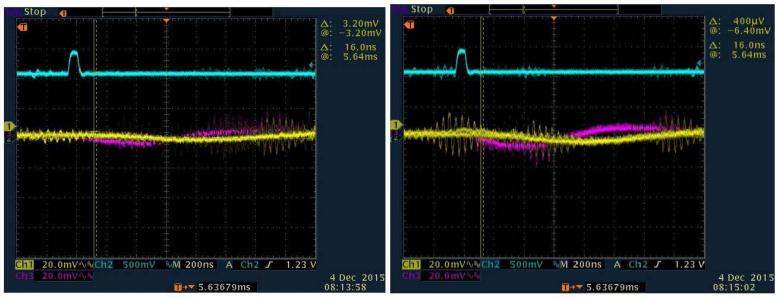
500MHz Board Voltage Test with Compression OFF/ON (No Caps)

Channel 2 =L1A pulse Channel 3 = VCCINT = 1.2Vcc Channel 1 = +1.2V PLL = 1.2Vcc filtered No real problem shown on the 500Mhz board.

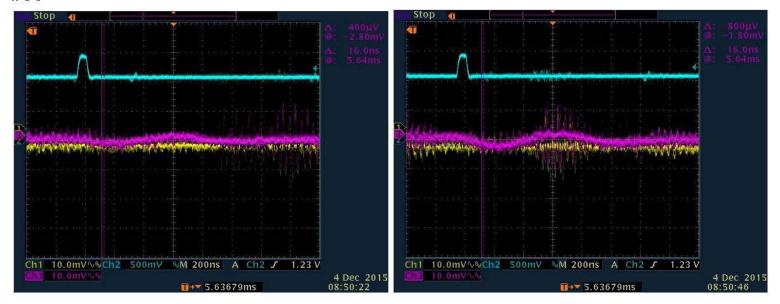
500MHz Board Voltage Test with Compression OFF/ON (With two 100uF Caps)

Channel 2 =L1A pulse
Channel 3 = VCCINT = 1.2Vcc
Channel 1 = +1.2V_PLL = 1.2Vcc filtered
No real problem shown on the 500Mhz board.
